Hydrogeological Investigation Report 4 Campbell Drive, Uxbridge, Ontario

Oak Valley Health

August 29, 2024
02310769.003

Oak Valley Health Hydrogeological Investigation Report 4 Campbell Drive

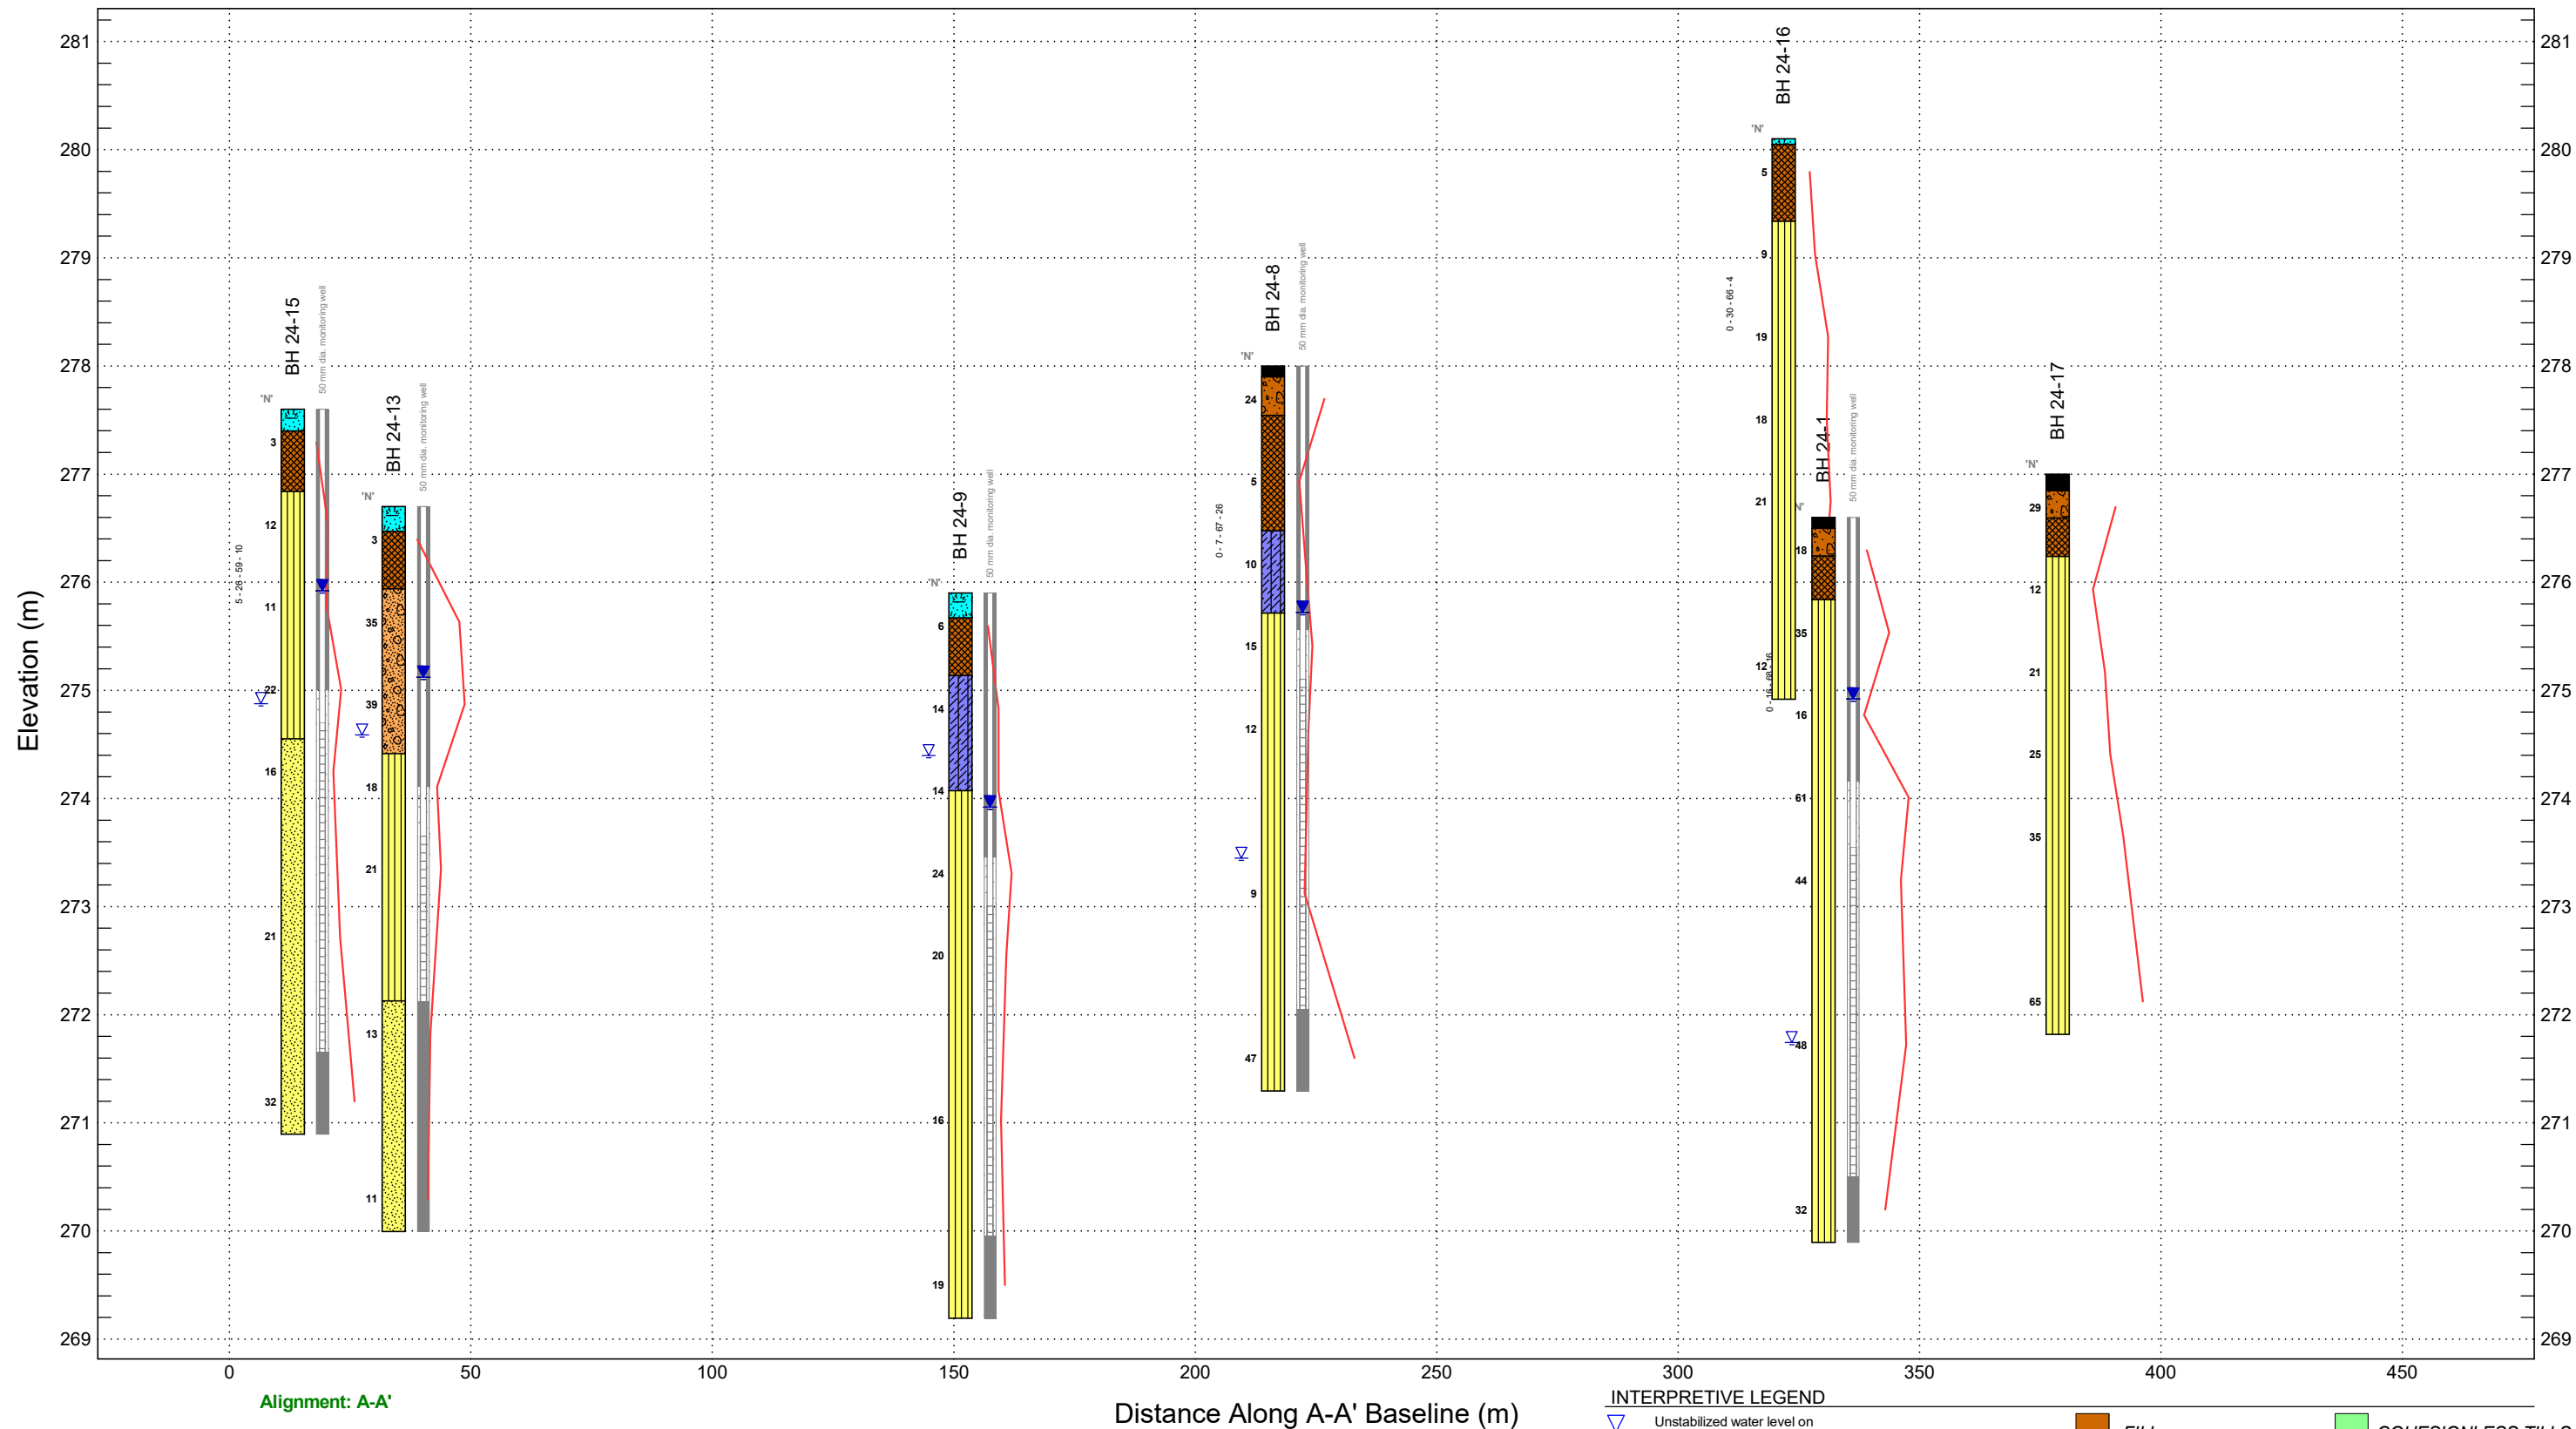
LITHOLOGY GRAPHIC LEGEND

The detailed stratigraphic conditions are presented on the accompanying borehole logs provided in **Appendix E**. A subsurface profile of the Site is provided in **Figure 4**. Characterization of the various soil types, including grain size analysis, was conducted and is presented in **Appendix F**.

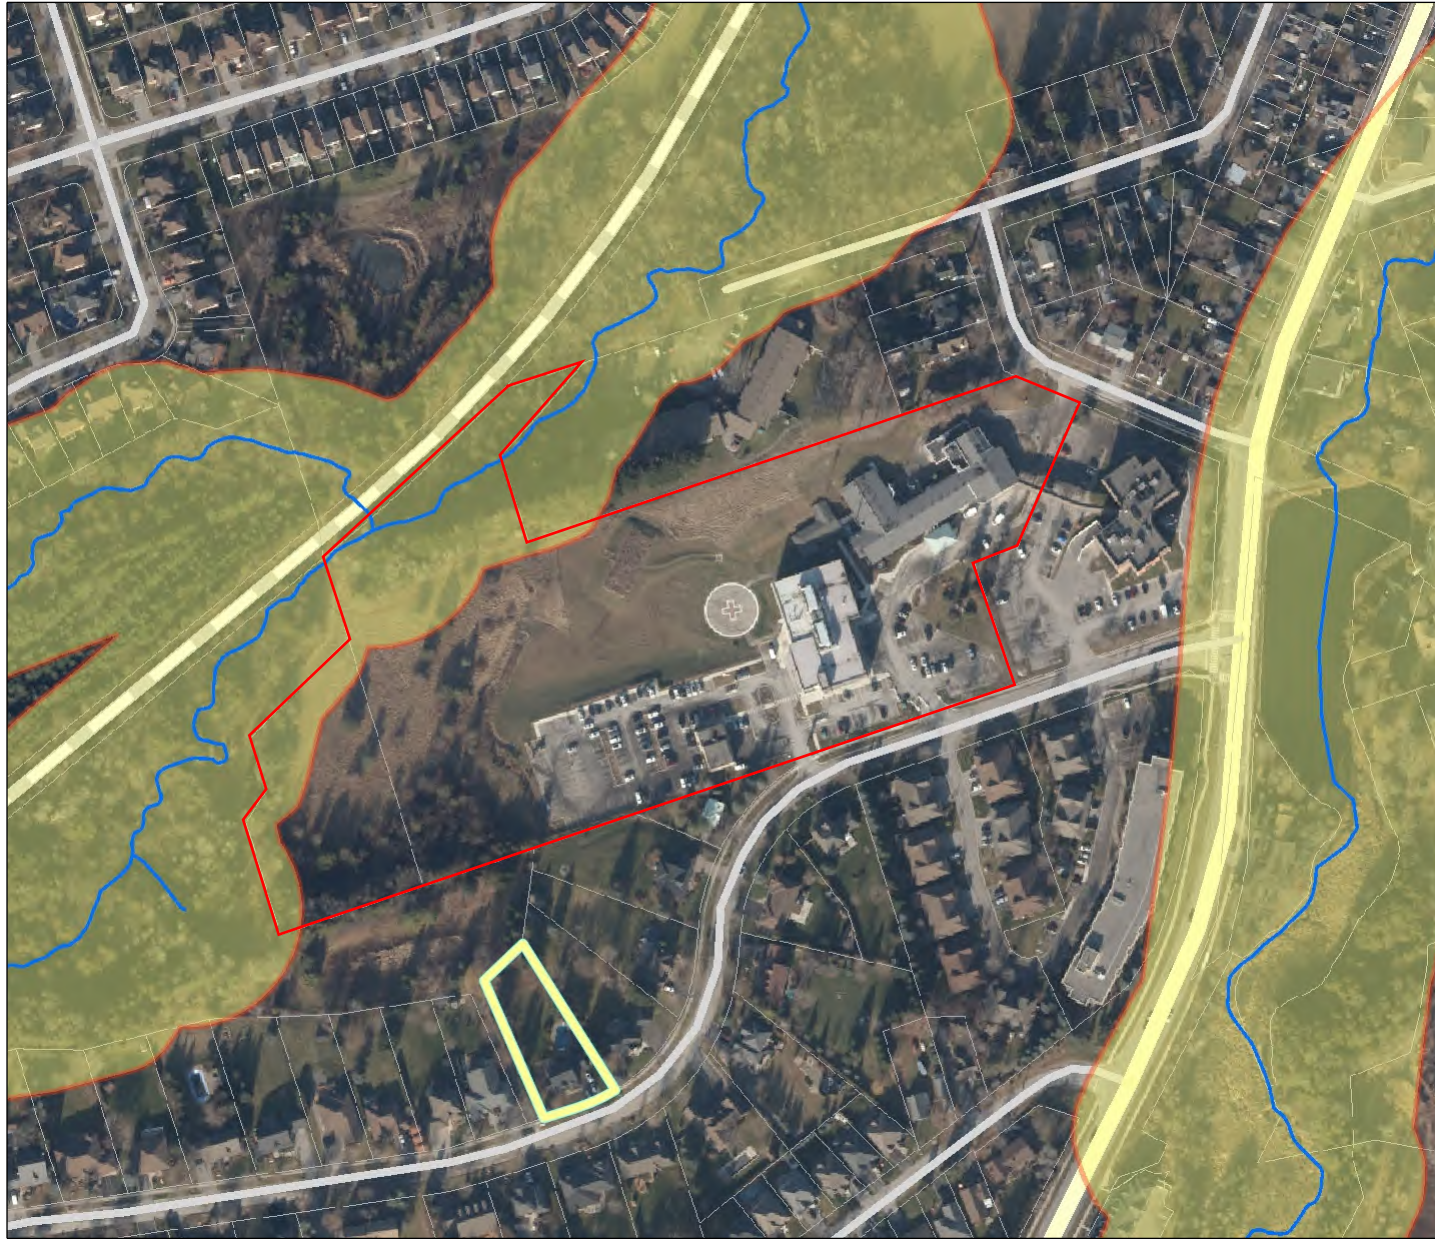
LSRCA Regulated Area

Lake Simcoe Region
conservation authority

subject site is partially located within a regulated LSRCA area. A tributary of Uxbridge Brook passes through the northwestern corner of the property, and therefore there are associated hazards (Meander belt erosion, erosion Hazard and flooding). Natural Heritage features (woodland) and Hydrologic features (wetlands) were also identified in the study area. Regulatory and watershed maps are presented in **Appendix A**.
